Jun 3rd, 2026

[Address removed], Naples, FL

# Home Inspection Report

John Voige / Naples Pro Inspect

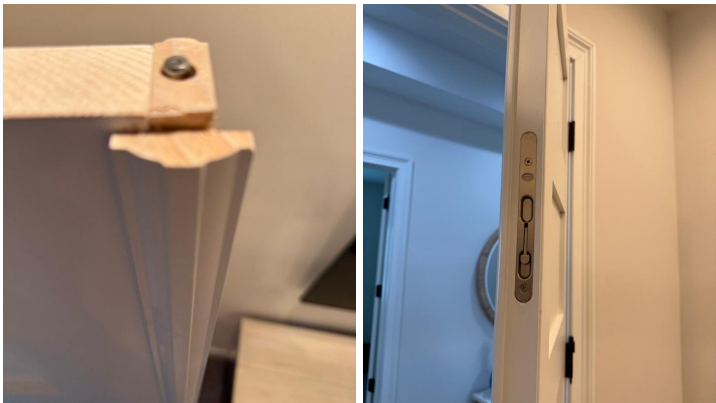
15.6 DOORS

The pin to secure the door to the frame does not extend into the strike plate
